HERITAGE AXS PATRIMOINE

RAPPORT DE RECHERCHE

Soumis à Normes d'accessibilité Canada

Dr. Ernesto Morales
Université Laval

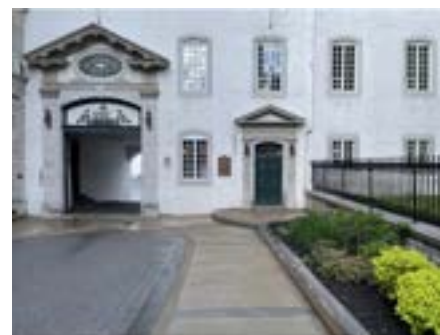
Figure 1a. The main entrance

Main entrance : In total, 35 respondents identified eight elements as obstacles related to the accessibility of the main entrance of the Old Seminary for a total of 101 mentions of obstacles (each respondent could identify up to three obstacles) (Table 2; Figure 1). The three most frequently identified obstacles were 1) the step at the entrance for 19 respondents (54.3%), 2) the doors and handles for 16 respondents (45.7%) and 3) the sidewalk for 14 respondents (40.0%). Other obstacles identified were: lack of identification of the entrance, lack of signage, lighting, surface of the ground outside (texture, color, patterns) and lack of tactile cues .

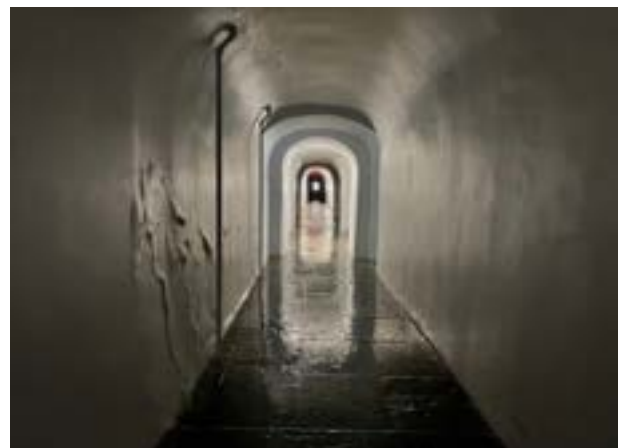
Figure 2a. The corridor

Corridor : In the corridor, 12 items were identified as barriers, of which the three most common were: 1) lack of handrails, identified as an obstacle by 17 people (48.57%); 2) the length of the corridor and 3) the floor area, selected as barriers by 13 people each (37.14%). Other elements were the absence of seats, lighting, reflections or glare, walls, width of the corridor, colour contrast between the floor and walls, absence of signage, lack of tactile cues and others.

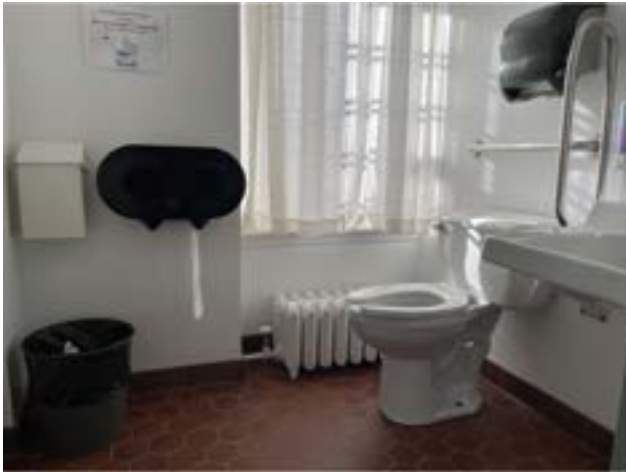
Figure 3a. Toilet at the Vieux-Séminaire

Toilets A total of 35 respondents identified 12 items as barriers related to the accessibility of a washroom at the Vieux-Séminaire for a total of 101 mentions of barriers (each respondent could identify up to three barriers) (Table 4; Figure 3). The three most frequently identified obstacles were 1) grab bars for 9 people, (54.3%), 2) locating accessories for 15 people (42.9%) and 3) space for maneuvering and transferring for 10 people (28.6%). Other barriers identified include: sink, lack of countertop, flushing mechanisms, washroom identification sign, floor surface (texture, colour, patterns), window, lighting, colour contrast, and lack of tactile cues.

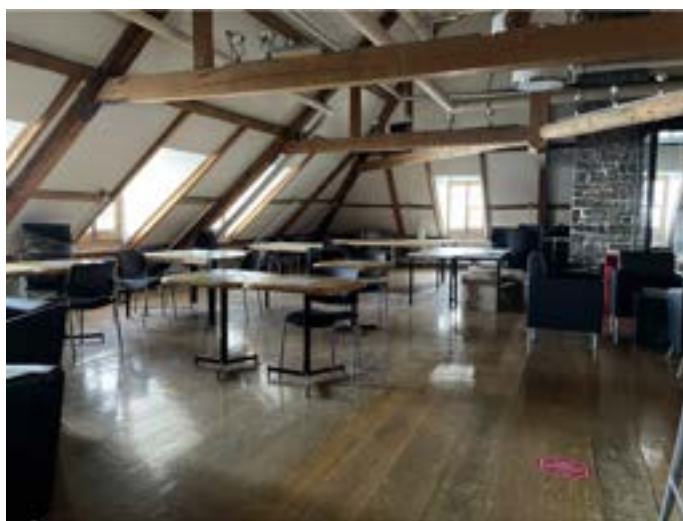
Figure 4a. The coffee shop

Coffee shop : A total of 35 respondents identified 11 elements as barriers related to the accessibility of the Café du Vieux-Séminaire for a total of 104 mentions of obstacles (each respondent could identify up to three barriers) (Table 5; Figure 4b). The three most frequently mentioned elements were: 1) the circulation space, identified as an obstacle by 17 people (48.6%); 2) tables, which were selected by 16 people (45.7%) and 3) seats, which were selected as obstacles by 11 people (31.4%). Other elements mentioned were the gable ceiling and walls, windows, lack of signage, lack of tactile cues, reflections or glare, lighting, and the "other" element

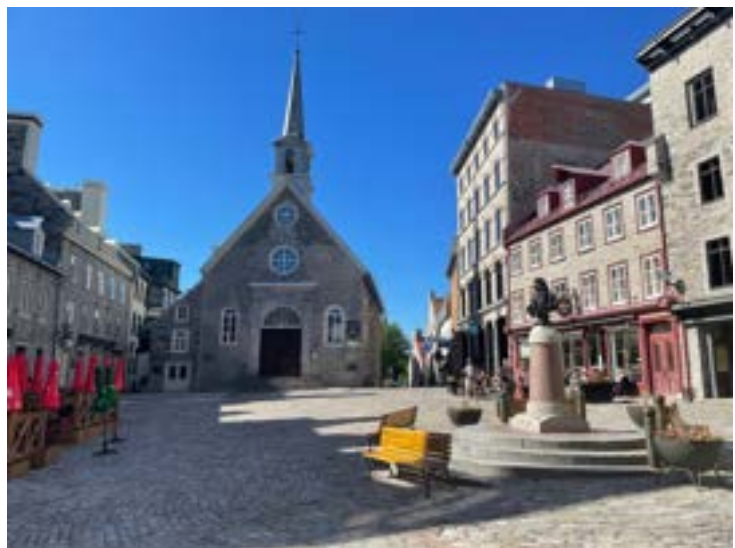
Figure 6a. Place Royale courtyard

Place Royale : A total of 35 respondents identified 10 items as barriers related to the accessibility of Place Royale for a total of 102 mentions of barriers (each respondent could identify up to three barriers) (Table 7; Figure 6b). The three most frequently identified obstacles were 1) the floor surface for 17 people (48.6%), 2) the slope of the ground for 15 people (42.9%) and 3) the entrances to shops for 15 people (42.9%). Other barriers that were identified were: insufficient rest areas, lack of tactile cues, lack of shelter or covered space, benches, traffic space, lack of signage, and lighting.

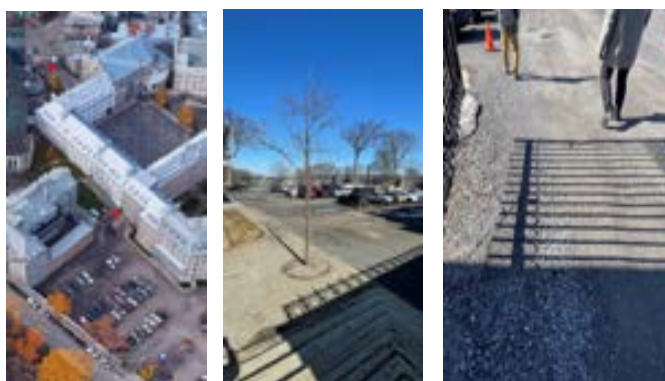
Figure 7. Images of the parking

- o Lack of demarcation of parking spaces in the parking area leading to various accessibility problems :

- Difficulty in determining whether the measure of accessible parking spaces meets the recommended minimum clearance to allow a person in a wheelchair to get in and out of their vehicle.

- Gravelled surface with sliding possibilities and difficult to navigate in a wheelchair.
- Inadequate signage of accessible parking spaces (small sign, and therefore difficult to see from a distance from the entrance to the parking lot).

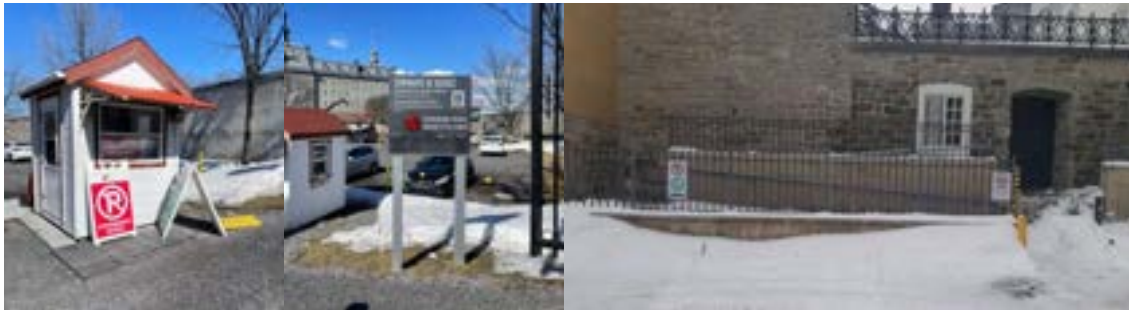
Figure 8. Images of the parking

- Lack of shelter for designated accessible parking space.
- Unobstructed accessible parking space (snow) at times

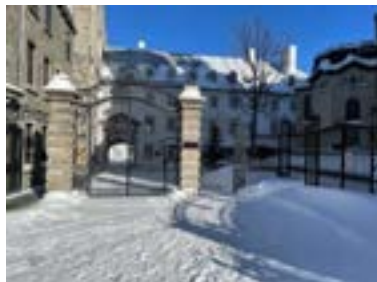
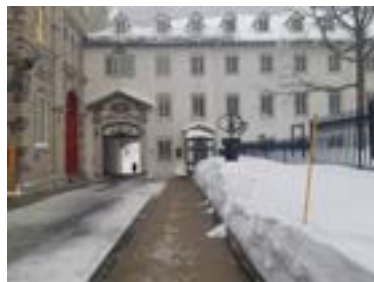
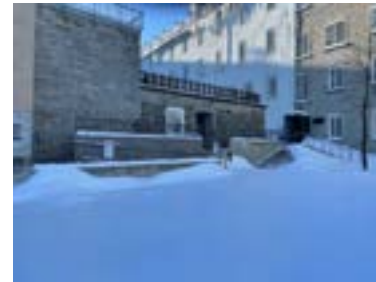
Figure 9. Images of the entrances to the School of Architecture at the Old Seminary

Some elements should be reviewed concerning the **external paths leading to the building**:

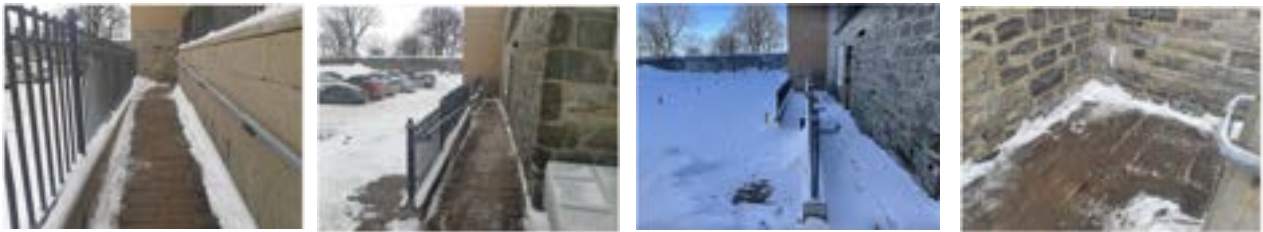
Figure 10. Images of the secondary entrance ramp

Several features could be improved with regard to the exterior access ramp leading to the SECONDARY entrance, which is the one adapted for people with reduced mobility:

- Relatively pronounced gaps between the planks of the wooden access ramp. Limited width of the exterior ramp. Restricted dimensions of the landing. No contrast or anti-slip strips available. Exterior ramp leading to the SECONDARY entrance not cleared (snow) at certain times. Absence of handrail on one side of the ramp and metal handrail without extensions at the beginning and end of the ramp. Lack of protection in the delivery area. Relatively pronounced gaps between the planks of the wooden access ramp.
- Limited width of the exterior ramp.
- Restricted dimensions of the landing.
- No contrast or anti-slip strips available.
- Exterior ramp leading to the SECONDARY entrance not cleared (snow) at certain times
- Absence of handrail on one side of the ramp and metal handrail without extensions at the beginning and end of the ramp.
- Lack of protection in the delivery area.

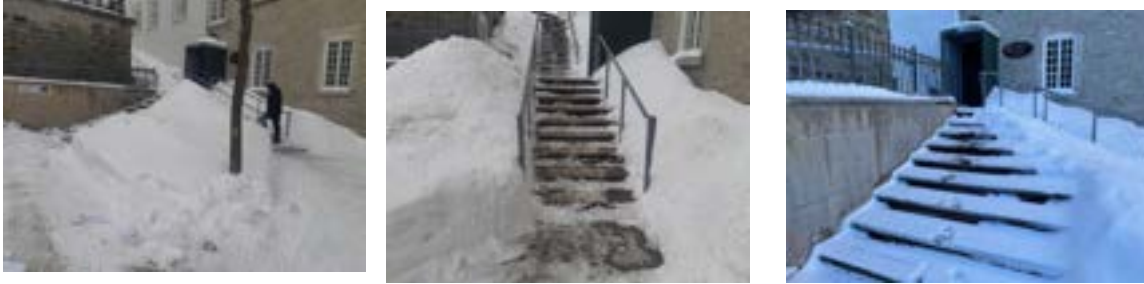
Figure 12. Barriers identified in Place Royale by number of participants

Several features would need to be improved with regard to the exterior staircase leading to the SECONDARY entrance, which is the one that is adapted for people with reduced mobility:

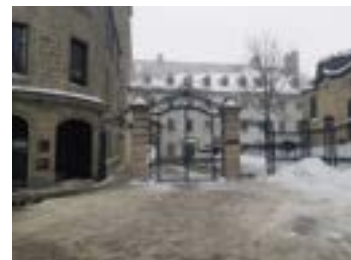
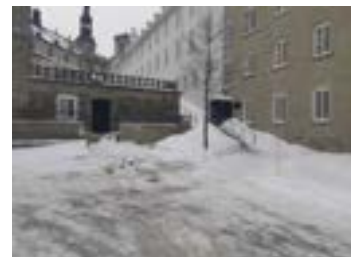
Figure 13. Entrance images

The section of the building studied as part of this project includes two entrances: the main entrance and the secondary entrance, which is the one that is adapted for people with reduced mobility. To make these entries accessible, several points of improvement would be relevant :

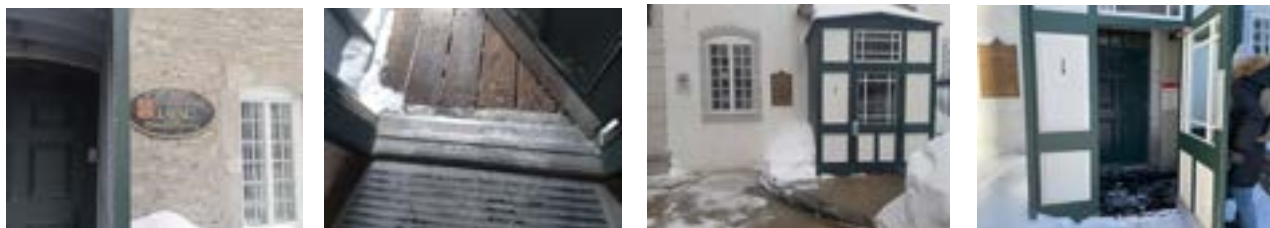
Figure 14. Images of the front doors

- The main entrance is not accessible as it has steps.
- None of the entrances have an automatic door or with a motorized opening .
- There is no path showing how to get to the main entrance or secondary entrance.
- At the main entrance, there is a plaque of Laval University, but it is black, difficult to see. The entrance is not easily identifiable.
- No tactile indications or other signage are available.
- The doors are relatively heavy.
- The doors have a high threshold.
- In winter, each entrance has two doors, leaving less space in front of the first door and also little space to be able to maneuver between the two doors.
- There are no cane-detectable barriers around the doors opening to the outside.
- Entrances do not offer a rest area or outdoor sitting.
- No shelter is provided except in winter.

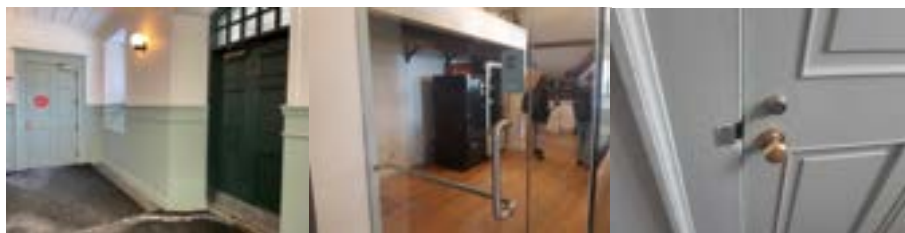
Figure 15. Images of the interior doors

- No motorized or self-opening doors are available on site.
- Many doors are heavier, especially fire doors.
- In some hallways, the doors open to the hallway and there are no tactile indicators.
- Almost all handles are button-shaped, which can make it difficult for people with motor disabilities to use.
- Glass doors on the premises do not have any visual indicators (e.g., coloured stripes).

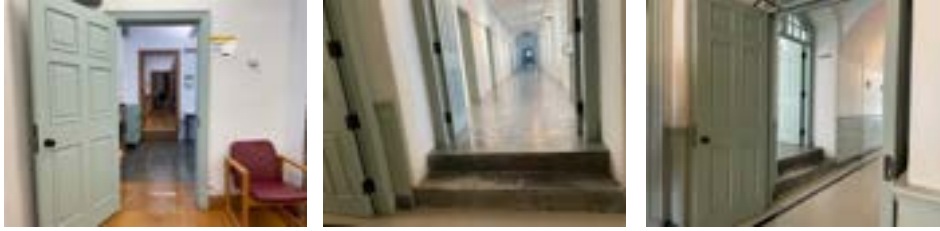
Figure 16. Images of indoor routes

- Some grade changes are present in the building, however, ramps and platform lifts are available in all grade changes encountered in the section of the building being evaluated for this project. However, there are other level changes that only feature stairs.
- The most used spaces are accessible, even if the autonomous use of equipment and spaces is not always possible.
- The structure of the building doesn't make sense and there aren't any tracking systems that help.
- There are no tactile indicators in open areas, but they are relatively small.

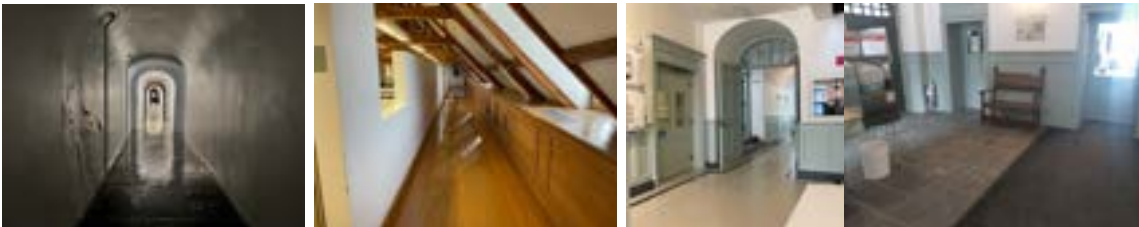
Figure 17. Images of corridors and vestibules

- Usually the hallways are clear (with the exception of the basement where sometimes there are recycling bins and the second floor or sometimes there are tables in the hallway).
- The contrast is generally good but the floor is reflective (the pale green + beige contrast could be improved).
- It would be relevant to have handrails in long corridors and there are none at the moment.
- No sitting or rest areas are available in the long corridors evaluated as part of this project.
- Lighting in some hallways is limited, especially in the basement.

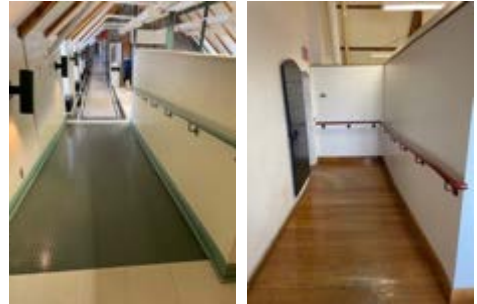
Figure 18. Images of interior railings

- The landings at the beginning and end of the ramps are not always large enough and sometimes are in transit areas.
- There are no contrasting non-slip strips.
- There is one handrail only and only on one side of the ramp.
- Some ramps are not easily located and could therefore be indicated with signage.

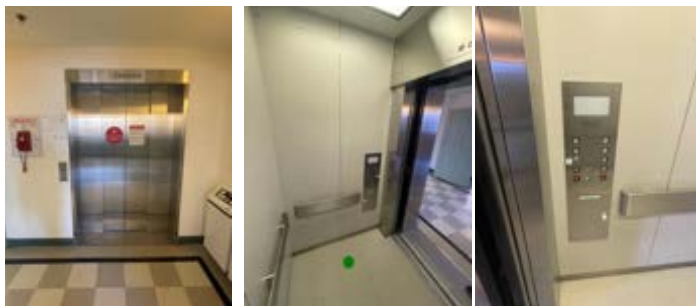
Figure 19. Images of the elevators

- No indication of the elevator is available, and it is not easily visible, and it is not close to the main entrance.
- There are no tactile and auditory cues and the order of the numbers is not obvious.
- The elevator doors reopen automatically but there is no motion sensor, so the door can hook the person who is in the elevator door frame.
- The buttons do not have braille or raised characters.
- Audio indications are not provided.
- The visual indications of the elevator offer limited information. This indicates the level we are going to, but not the level we are at.
- No handrails are available in the elevator.
- There is no color contrast between the floor and the walls of the elevator, inside the car.
- No mirrors are available.

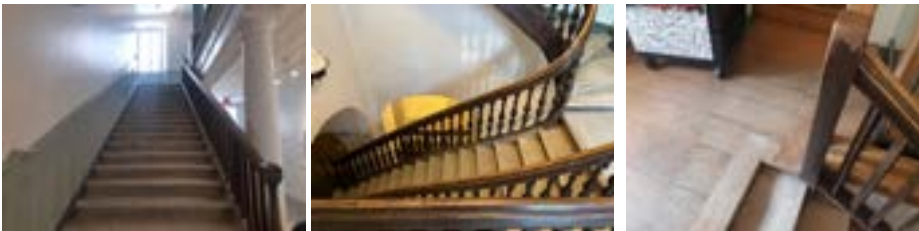
Figure 20. Images of interior stairs

- There is a landing at the bottom and top of the stairs, with sufficient space at the bottom, but at the top, in the event that the doors are closed and have to open when there are passers-by, the door takes up manoeuvring space that can get in the way
- In the majority of stairs, the handrail is located on one side only and has a single height.
- No touch indicator is available.
- The stairs are beige (wood color) and there are no contrasting anti-slip strips on the nose of the steps.
- The stair nosings are rounded, but are protruding to the point where it becomes risky to get stuck in them when climbing the stairs.
- The lighting is good, but it's not even, creating small areas of shadow that can hinder traffic.

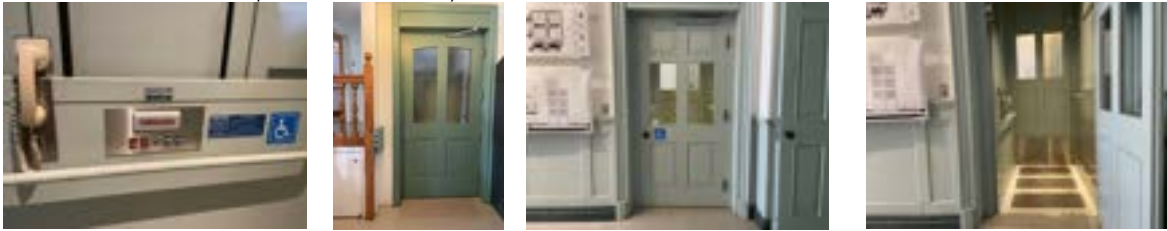
Figure 21. Images of the lighting platforms

- o Platforms do not provide auditory feedback.

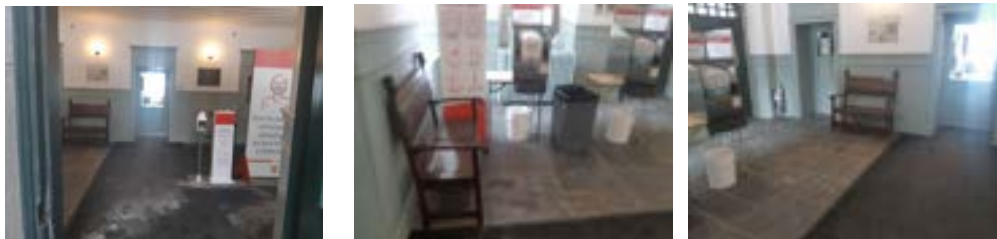
Figure 22. Images of the lobby

The lobby and reception area are not clearly signposted and the layout of the venue is not intuitive

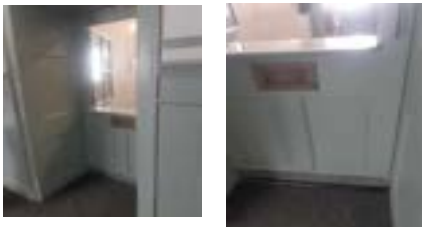
Figure 23. Images of the reception desk

- Security inaccessible from the main entrance (currently only visible).
- Lack of countertops at different heights.
- Limited signage to get to the security post.
- Little contrast between the security post and adjacent surfaces.
- No assistive communication technology available.

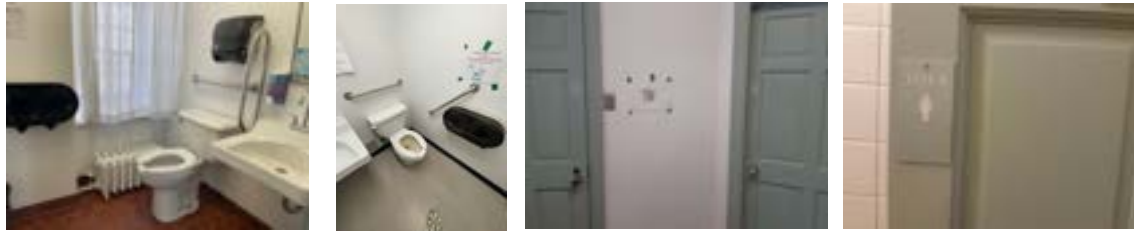
Figure 25. Images of washrooms

- o Several adapted toilets are available on site, but there are none in each group of toilets.
- o The amount of universal toilets is limited.
- o The building has signage using international standardized symbols for all washrooms, but there are no raised or braille letters and/or symbols.
- o Signage is installed at the recommended height but on the door rather than on the wall and the contrast with the surface area between the signage and the door is limited.

- o No electric door is available for the toilet.
- o The free space of the toilet doors is limited (about 800 mm), which limits the entry of people with reduced mobility.
- o None of the door fittings are accessible. The knob is round and the lock requires fine finger control.
- o The free space inside the universal toilets and cubicles is limited (about 1200mm).
- o Accessories are often placed too high or in hard-to-reach places.
- o There is no electrical outlet or emergency button in the universal toilet.
- o No changing tables are available on the site for children or adults.

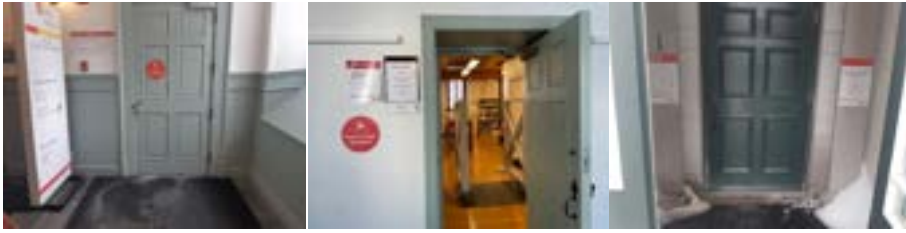
Figure 26. Images of general signage

Regarding general signage, several shortcomings and key points for improvement were encountered during the evaluation :

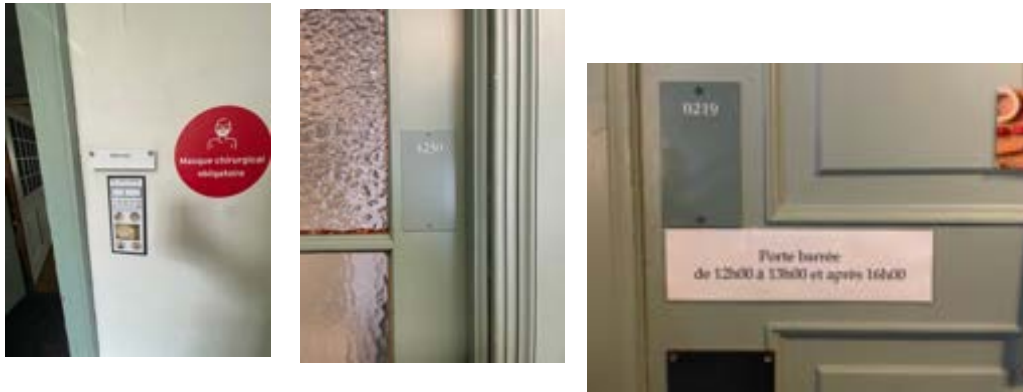
Figure 27. Images of room identification signs

- Several rooms have a room number but not the name or function of the room.
- None of the rooms have a tactile sign, with raised or braille characters.
- Panels are often placed on the door rather than on an adjacent surface.

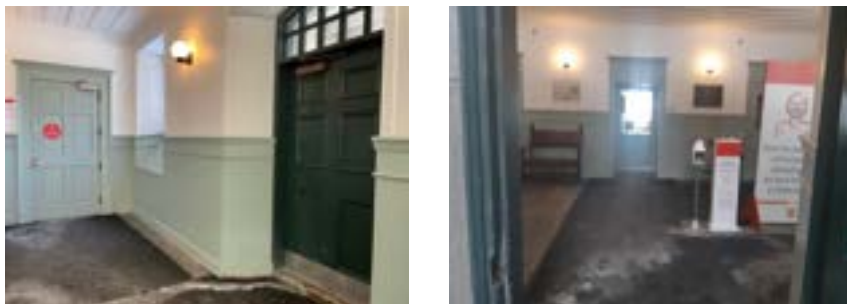
Figure 28. Images showing lack of directories

- No directory has been found in the site, but it could facilitate orientation in the building as well as the identification of key places.
- The location of equipment or facilities is not put forward.

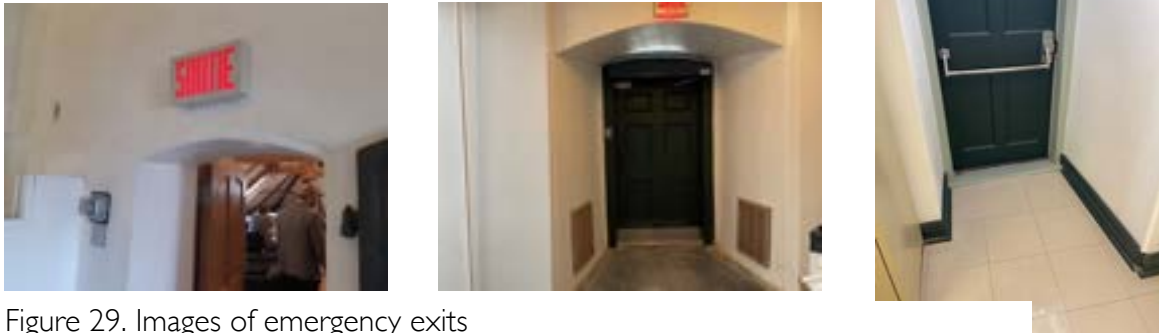
Figure 29. Images of emergency exits

- o No emergency refuge areas or evacuation equipment for people with reduced mobility have been identified.
- o Emergency exits are not easy to locate.
- o The space near the emergency exits is sometimes limited.

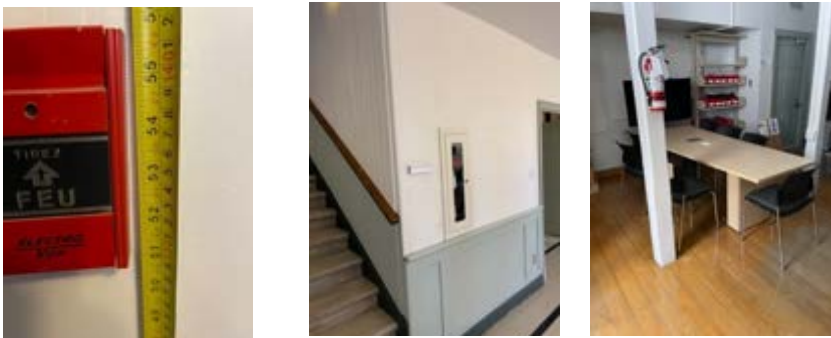
Figure 30. Images of fire equipment

- No visual fire alarm is available in the site.
- Fire equipment (e.g., fire extinguishers or alarm triggers) are often placed too high.
- There is no notification system available in case of emergency.

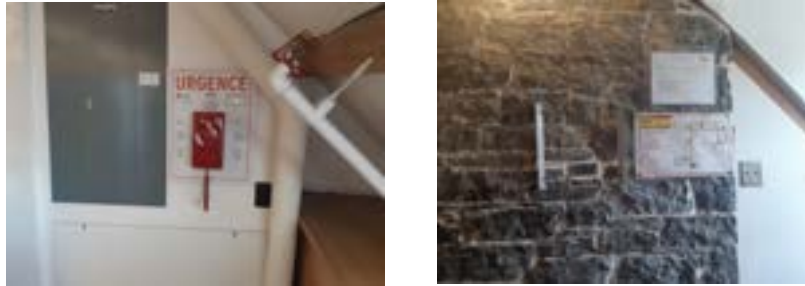
Figure 31. Images of evacuation instructions

- Some evacuation plans are presented on reflective surfaces.
- The font size of the instructions as well as the evacuation plans are small.
- No plan or instruction has an alternative format (e.g., touch).
- The information about the evacuation is often located too high.

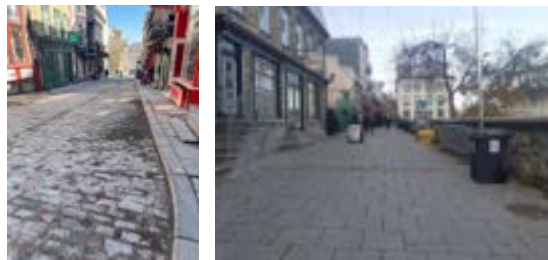
Figure 35. Images of Sous-le-Fort and Petit Champlain streets

- The clear width is not sufficient over the entire trajectory.
- Some barriers are present on the sidewalks, which forces the user to walk on the road.
- The majority of barriers lack contrast with adjacent surfaces.
- Some areas are pedestrianized, but this is not indicated.
- Some sidewalks on the second one do not allow the movement of people in both directions.
- The coating is not uniform.
- There are examples of puddles and areas in poor condition.
- Rue du Petit Champlain, Rue de Sous-le-Fort and Notre Dame as well as Place Royale have a significant inclination.
- Pedestrian crossing areas are not always indicated.
- Rue du Petit Champlain, Rue de Sous-le-Fort and Notre Dame as well as Place Royale have a significant inclination.
- Pedestrian crossing areas are not always indicated.

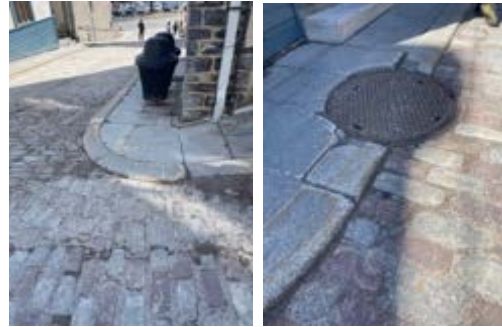
Figure 36. Images of obstacles in the paths

- There is a change in level between the pavement and the road and paved boats are not available.
- Barriers are present on the way (e.g., garbage cans, terraces, lampposts).
- Manholes are located on pedestrian traffic areas.
- Artificial lighting is limited.
- There are a few seats in the area but they are not suitable for all people (very limited).

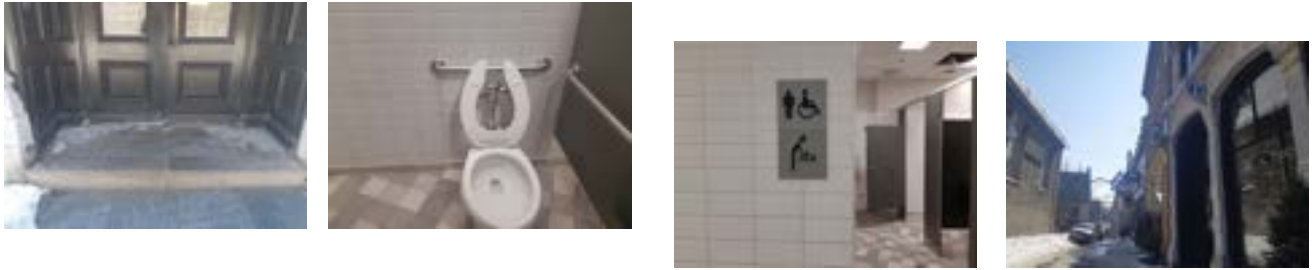
Figure 38. Images of toilets inside Place Royale

- No adult changing tables are available on the site.

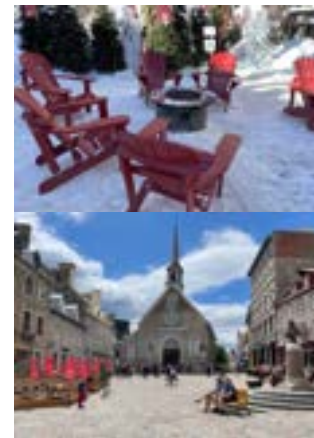
Figure 40. Images of rest areas

- Some rest areas in the sectors studied are not accessible or their access is not ideal (e.g., Felix Léclerc Park).
- The square at the end of Petit Champlain Street is not accessible because there are stairs to access it.
- The chairs are not scattered.
- A variety of seats is only available in the area that is not accessible.
- There are no year-round chairs (most are not available in winter-spring).
- The only shelter are the parasols in the square at the end of Petit Champlain Street in summer.
- The rest areas are a bit too dark in the evenings.

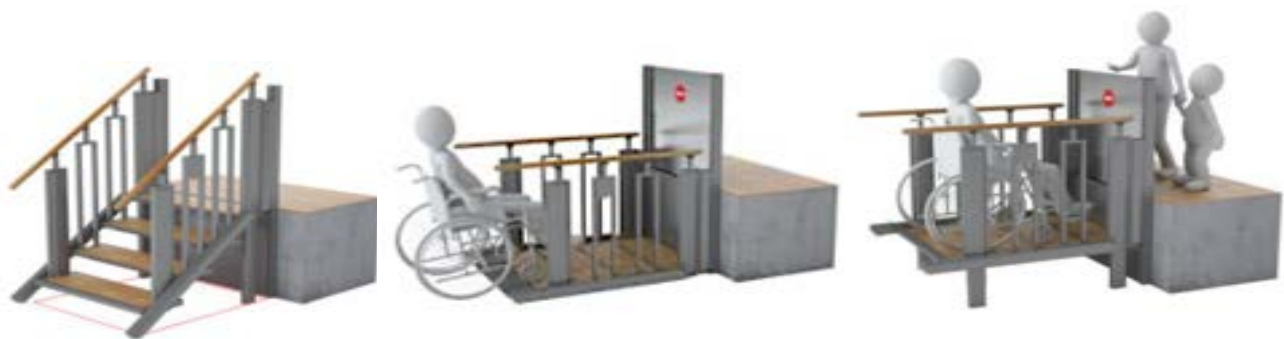
Figure 41. FlexStep model, manufactured by AXESS2 - (www.axess2.co.uk).

To address the lack of access to buildings due to steps, the lift model shown is the FlexStep model, manufactured by AXESS2 - Domestic and Commercial Lifts (www.axess2.co.uk). This elevator model was chosen because it could be easily integrated into the heritage context, with the steps themselves transformed into a platform (see Figure 41).

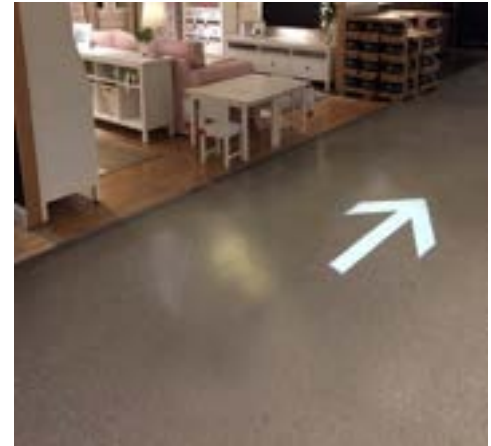
Figure 42. Projected signages used at IKEA

In connection with the lack of signage, the discussion revolved around the use of signage projected on the ground, giving rise to contrasting opinions. Some participants expressed enthusiasm for this approach, considering it positive. Others expressed concern about the need to place spotlights everywhere to support this method.

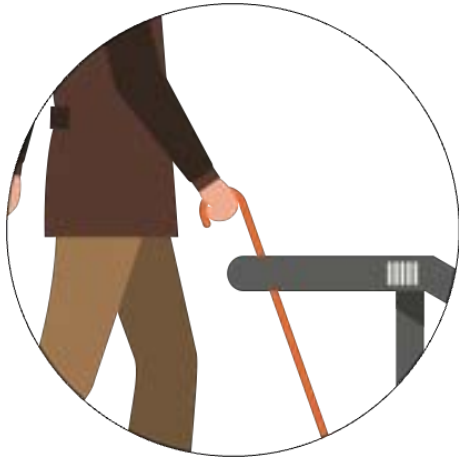
Figure 44. Guided handrail with tactile markers, by Lakoud

One of the proposals put forward to address some of the issues with the use of stairs was to add tactile indicators to the handrails of the stairs, to help people who are blind or visually impaired determine how many steps are left. These tactile indicators would provide crucial assistance by allowing users to physically feel and count steps as they ascend or descend, improving their sense of spatial awareness, and promoting safer navigation in the built environment. This initiative represents a concrete step towards greater inclusion and accessibility for people with visual impairments, allowing them to use the stairs with confidence and independently. However, more complex information than this would be too difficult to interpret tactilely and would therefore be discouraged.

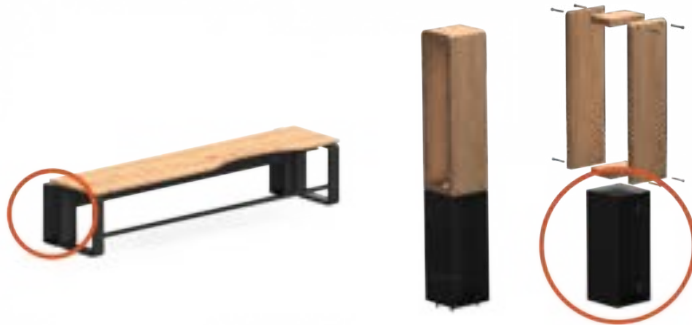
Figure 46. Proposal for a "Lego" unit from a bollard

- These bollards would serve as physical barriers between the different lanes, providing clear and tangible landmarks for pedestrians, cyclists and physical activity enthusiasts. The introduction of these bollards aims to create an environment where each user has a clearly demarcated space, which helps to reduce the risk of conflicts and accidents, while

providing a sense of security for people with visual impairments. One of the main characteristics of these charging stations is their removability. This design has been carefully studied to meet the specific climatic requirements of Canada's Nordic context, where snow and winter conditions play a major role. Removable bollards allow snow removal crews to carry out their operations throughout the winter, without impeding traffic or compromising safety. This flexibility is essential to ensure the possibility of shared streets throughout the year, considering seasonal variations and the weather challenges specific to each region.

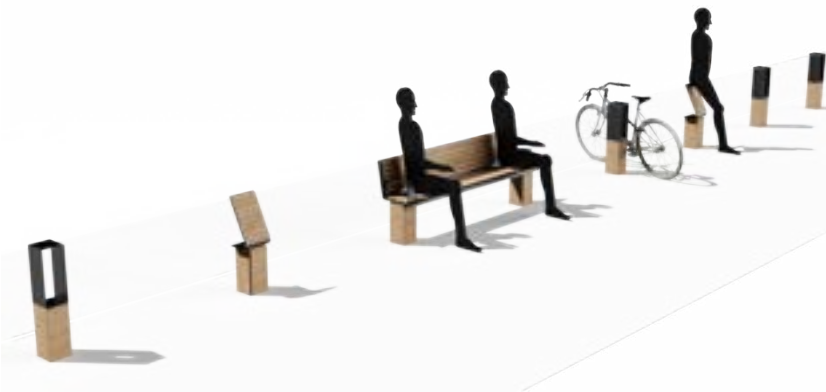
Figure 47. Proposal of the "Lego" concept of street furniture for heritage sites

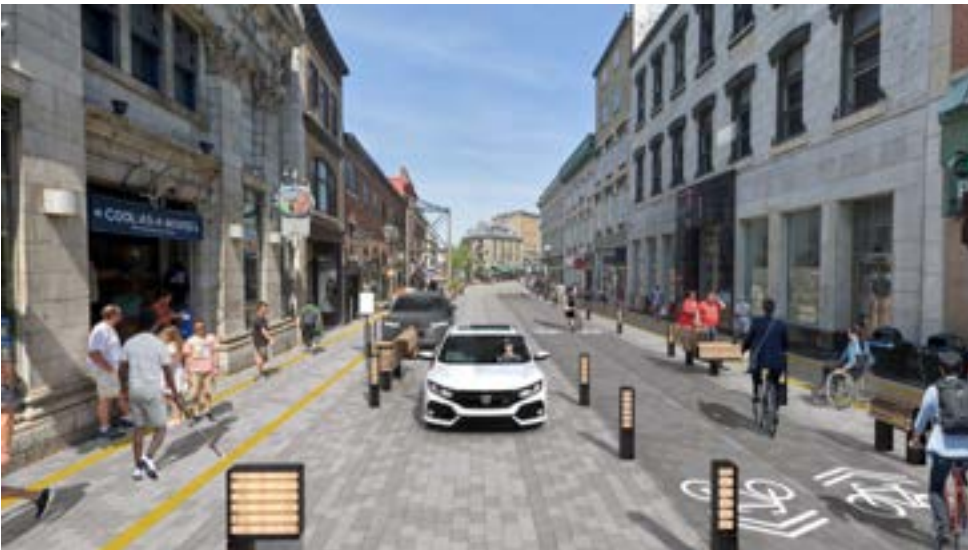
Figure 49. Proposal for the development of a shared street and street furniture on rue Saint Jean

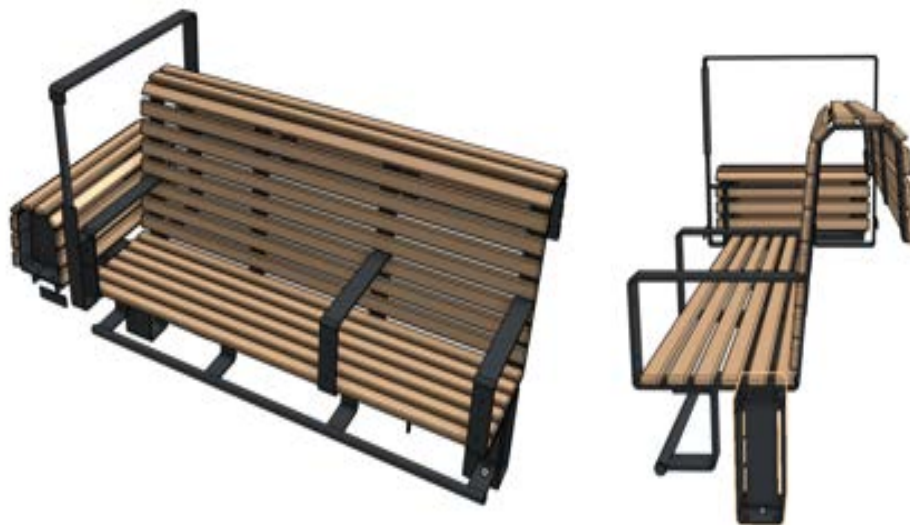
Figure 50. Proposition of inclusive bench exterior

- A universal access bench designed to meet the varied needs of users (see Figures 50 and 51), with a focus on accessibility, comfort and user-friendliness is proposed. The bench is equipped with a central armrest, to provide additional support for people with mobility difficulties or who need support when sitting down or standing up. By providing specific facilities for children, including a footrest, the bench is accessible and welcoming to all members of the community, regardless of age or physical condition. The addition of lumbar support to the back and one side of each bench is intended to meet users' needs for ergonomics and comfort.

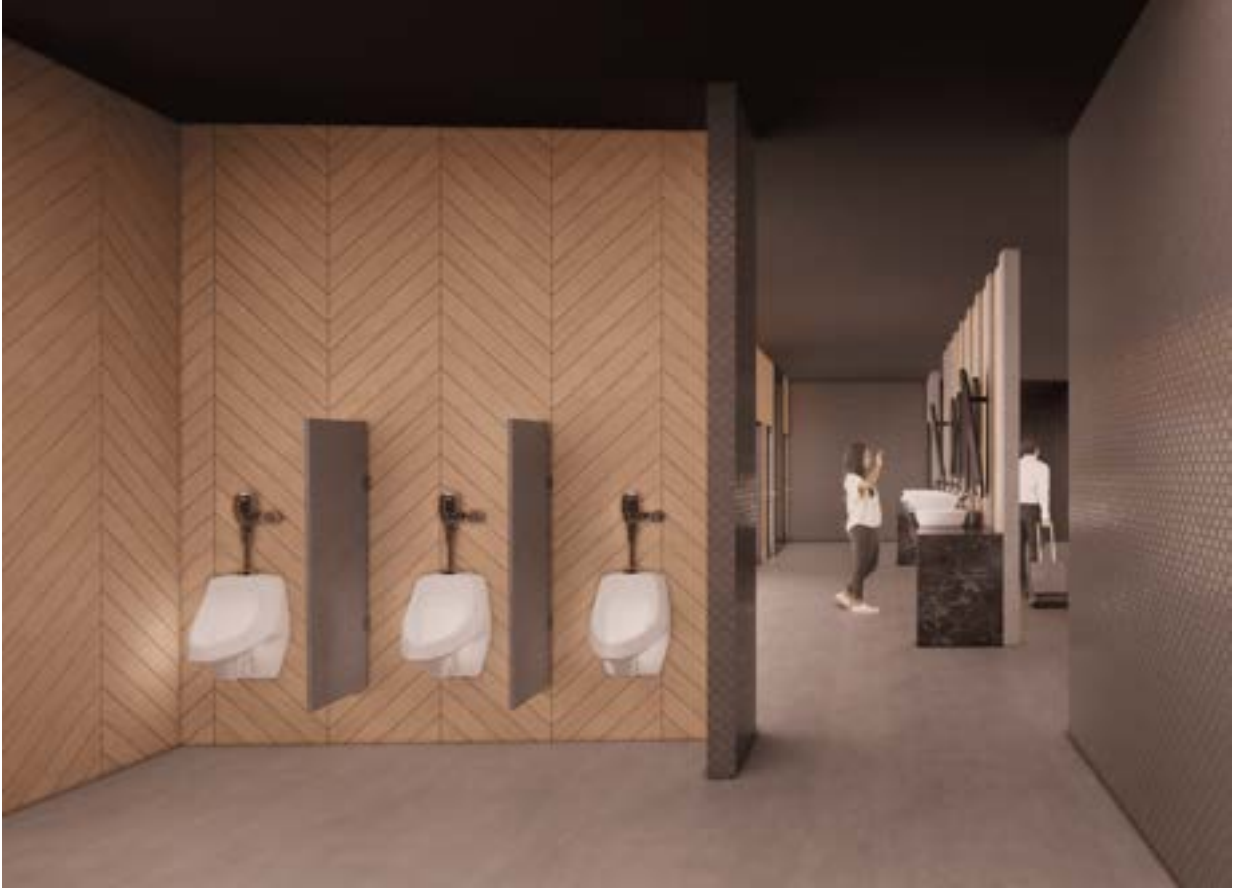
Figure 55. Seperate urinals
